Combustion Parts Repairs for Alstom Legacy Fleet

Ansaldo Thomassen offers combustor parts servicing for Alstom Legacy Fleet

Repair Capabilities EV/SEV Burners & Lances

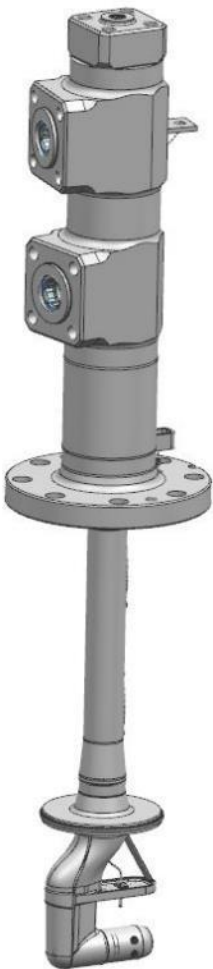
Balcony deformation

Balcony wear

New repair & upgrade implemented

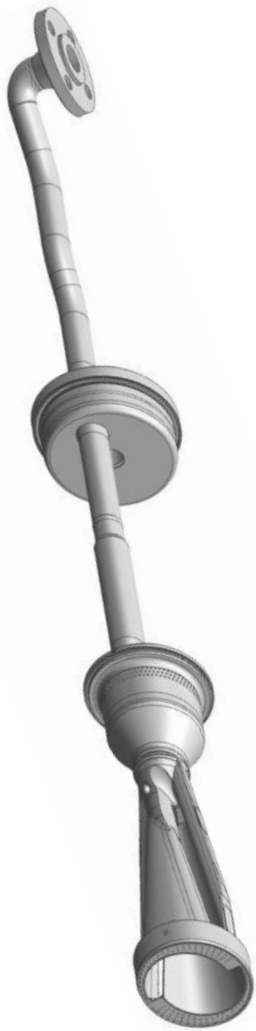
Roundness correction and Straightening

Repair welding

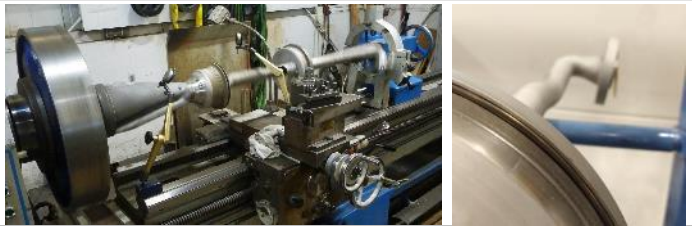
Machining

Flow testing and tuning
